Rimkus Consulting Group, Inc.
Eight Greenway Plaza, Suite 500
Houston, TX 77046
(800) 580-3228 Telephone
(713) 623-4357 Facsimile

Re: RCG File No: 11009971
LLV Number: 0209452
VMF Location: 1530 Greensmark Drive in Houston, Texas
Subject: Final Report

Rimkus Consulting Group, Inc. was retained to examine LLV 0209452, VIN 1GBCS10E4M2908832. The fire occurred on June 13, 2016 at around 12:30 P.M. the operator of the vehicle at the time of the fire, was unavailable for interview but reportedly stated the vehicle's engine died while delivering mail on his route and backfired during subsequent attempts to restart it. Soon thereafter, smoke was observed from beneath the hood as well as flames.

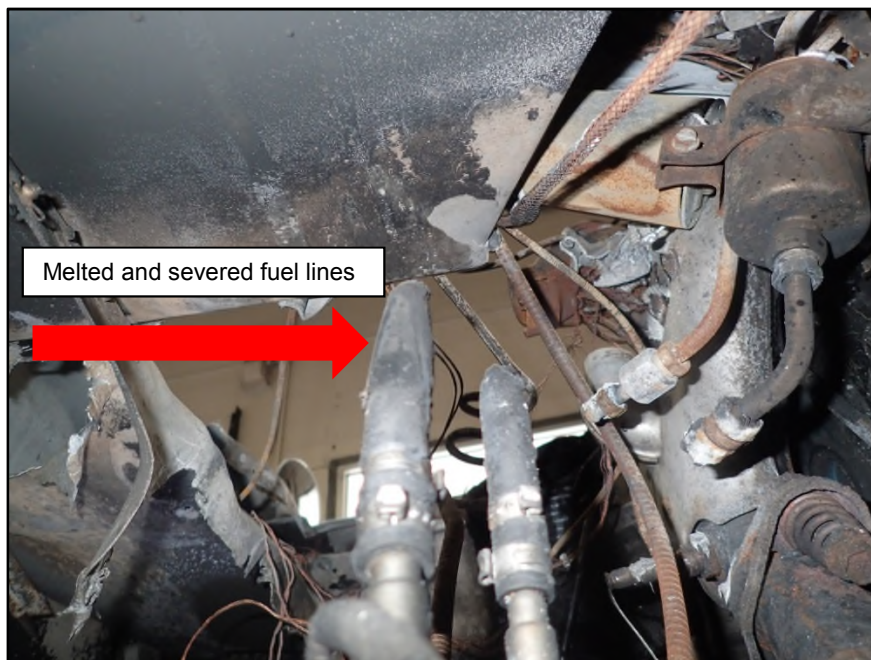
Photograph 4

One of the potential contributing factors was most probably due to physical damage to the rubber fuel supply line that was in close proximity to the exhaust manifold.

Close up view of area of origin from below.

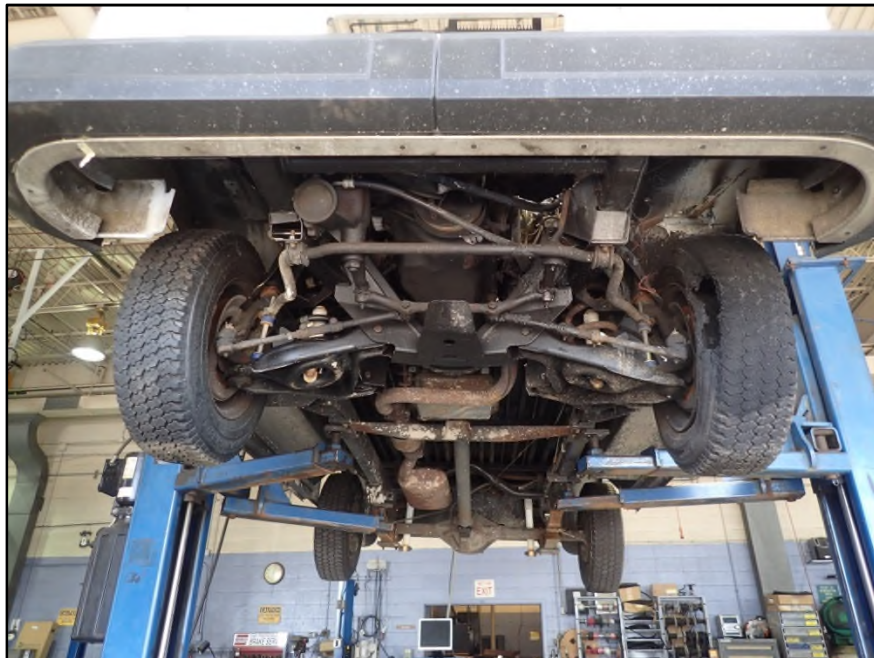
The vehicle was placed on a mechanical inspection lift and the undercarriage was examined. The vehicle was mounted on a GM frame and we did not observe any fire damage or anomalies to the undercarriage of the LLV. The fuel lines running along the chassis were examined and we did not observe any damage from the rear of the vehicle to the engine compartment. The LLV was equipped with a GM fuel filter system.

Photograph 6
Undercarriage of LLV.

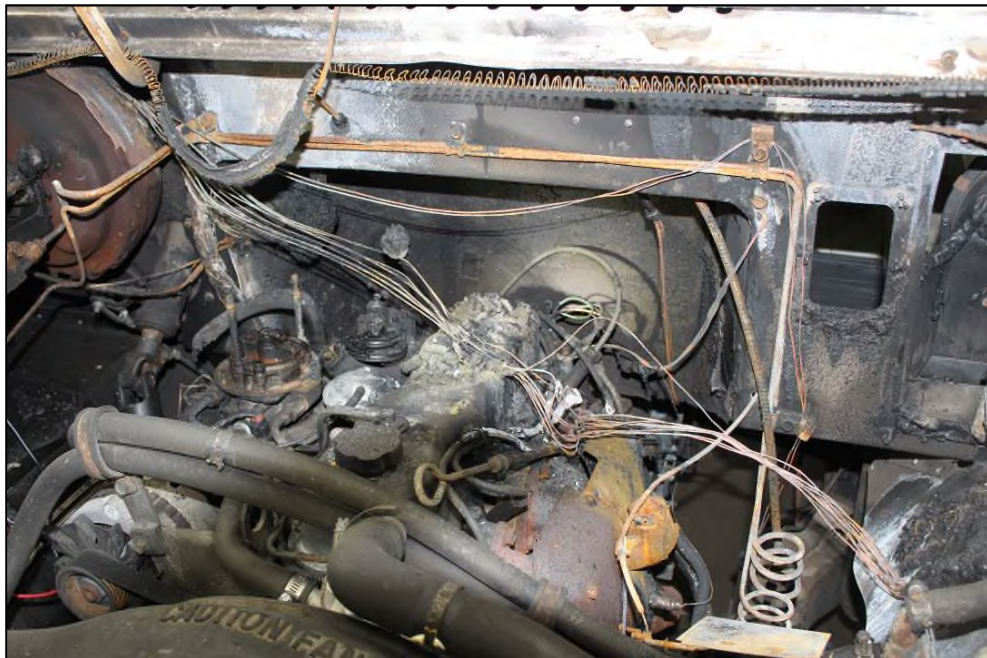
Photograph 2
Top of engine block with air filter removed.

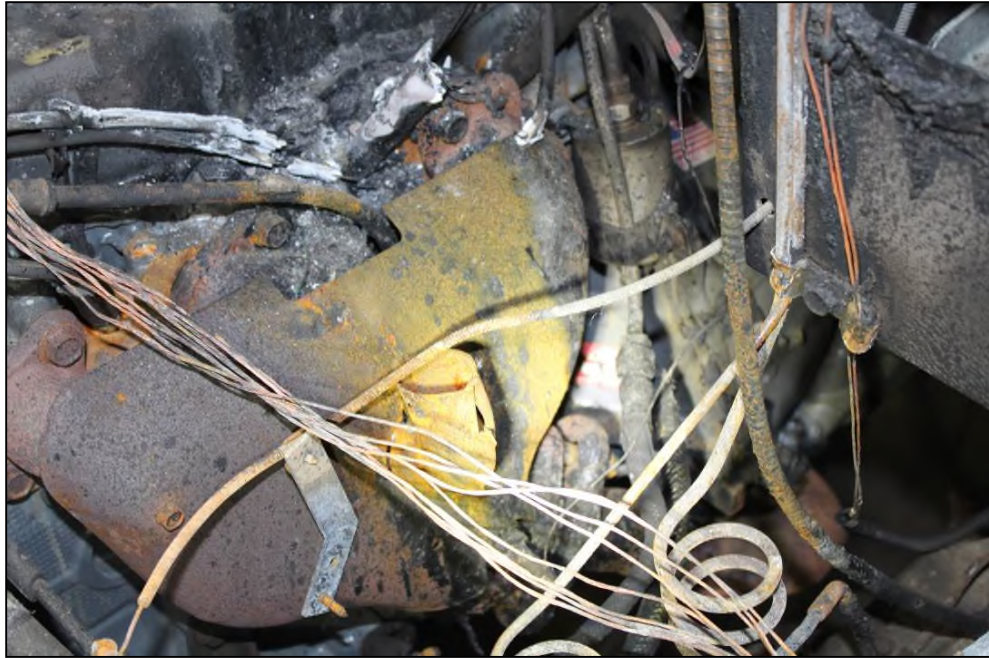
Photograph 3
Right side of engine.

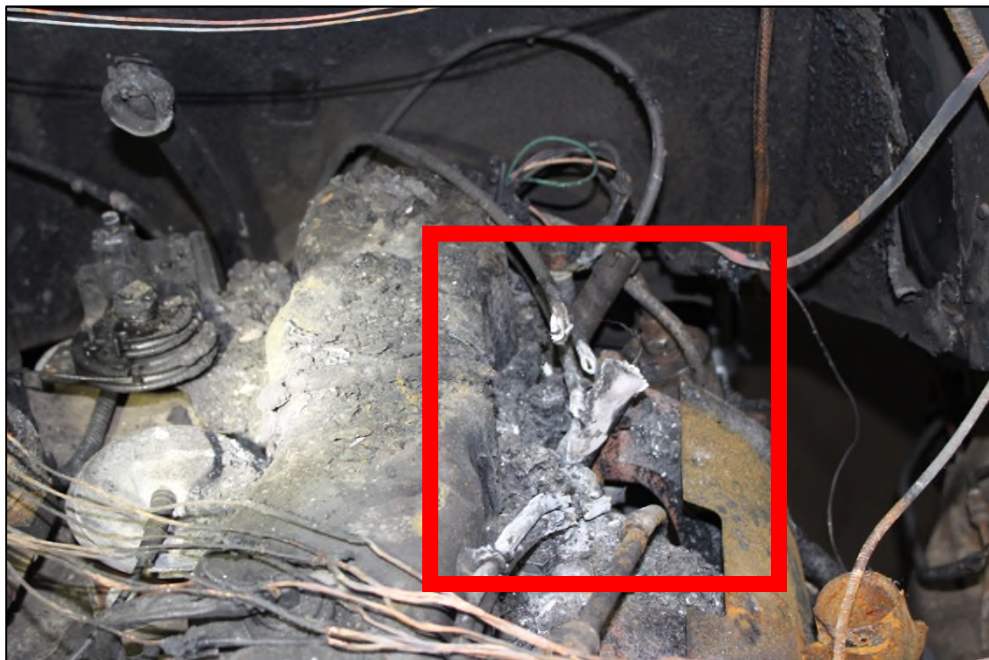
Photograph 4
Area with most severe burning.

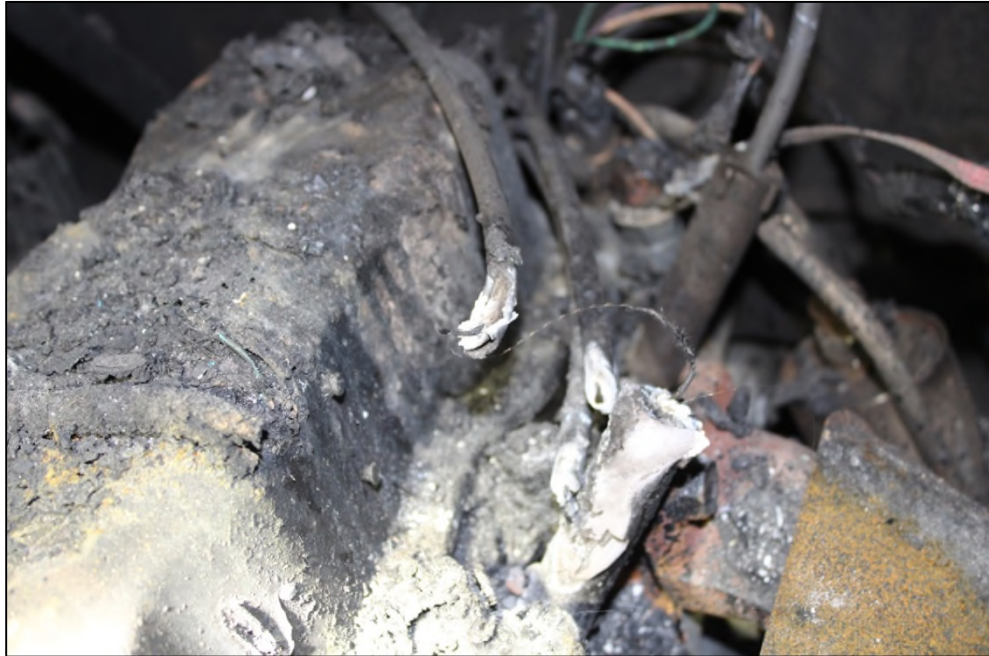
Photograph 5
Right side of engine.

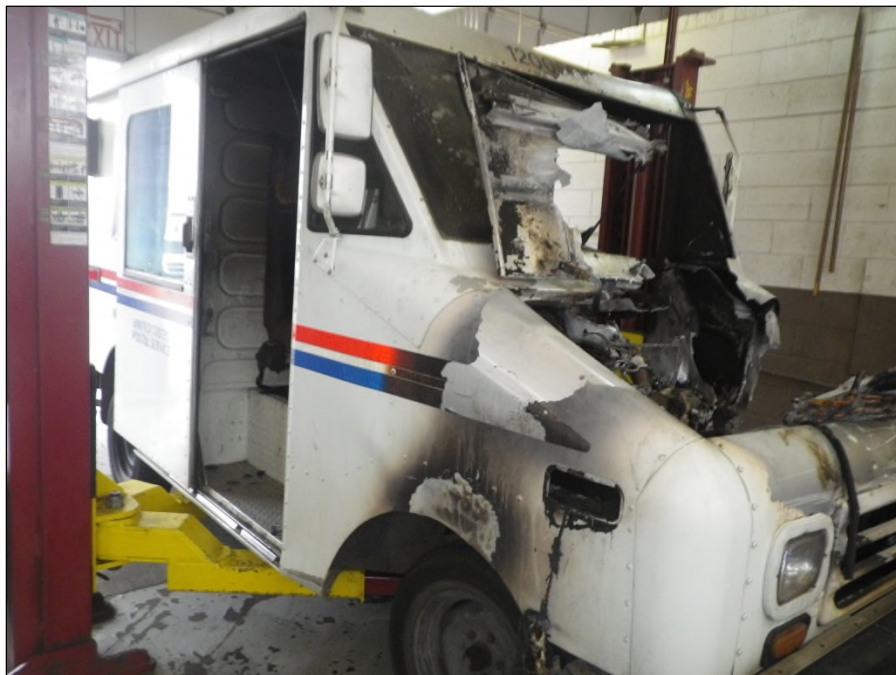
Photograph 2

View of fire damage to engine compartment and driver side of vehicle.

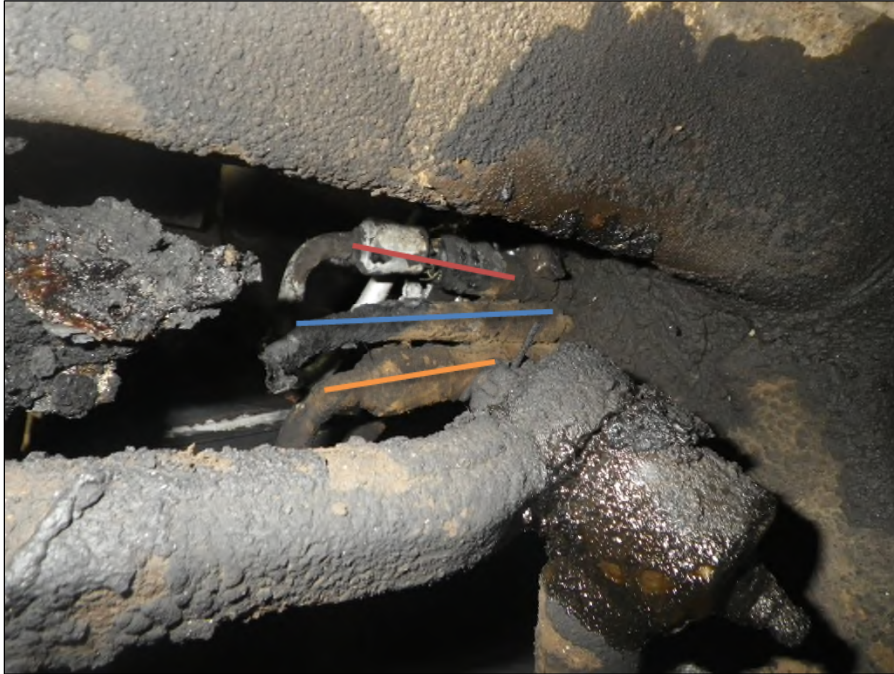
Photograph 3

View of fuel lines in area of origin. The red line is the separated supply line; the orange line is the intact return line; and the blue line is the fire-damaged vacuum line.

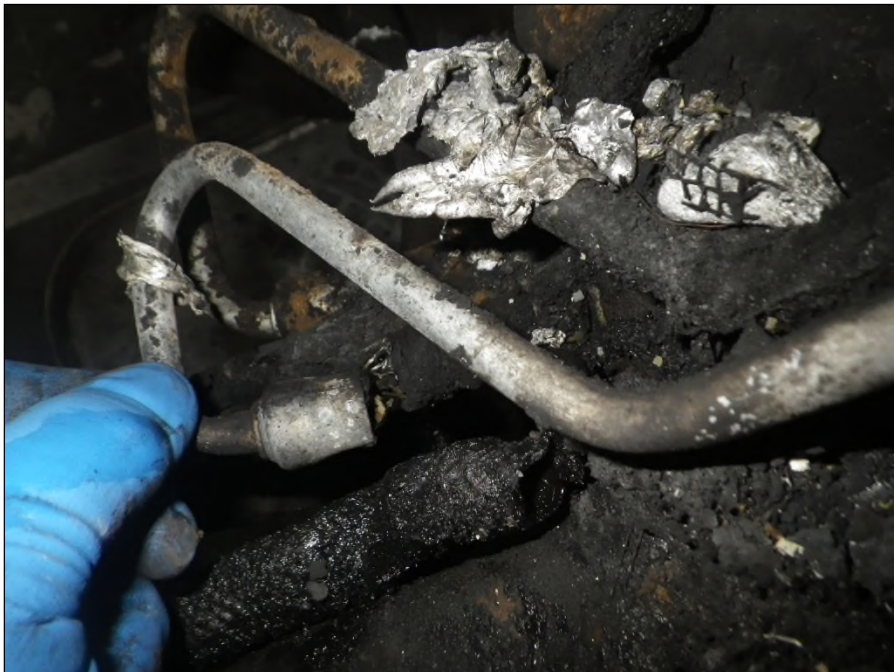
Photograph 4

View of separated fuel line in area of origin.

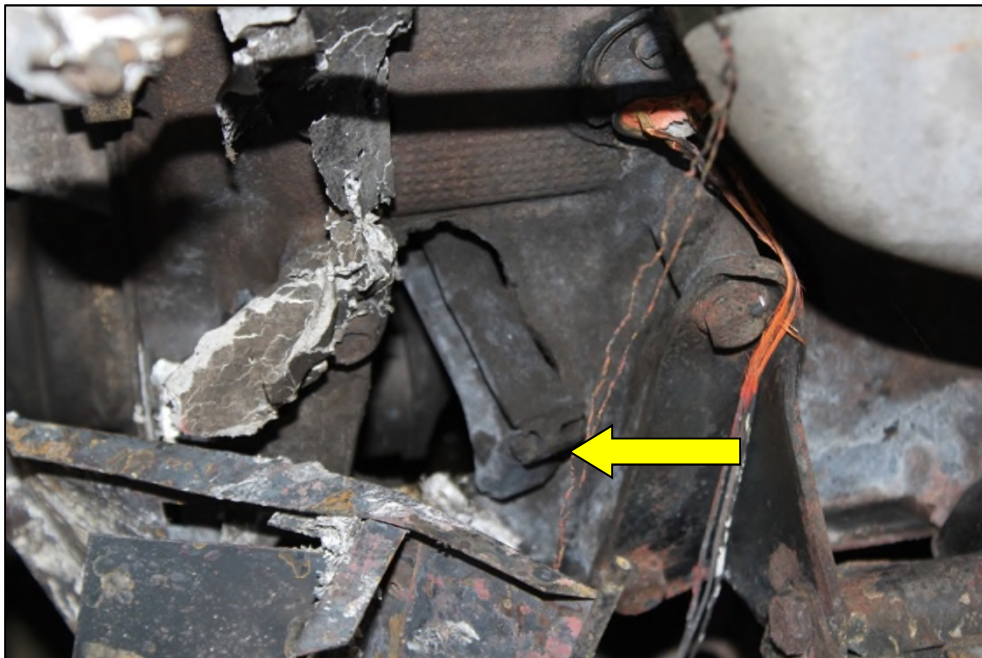
Photograph 4

Push rod for #1 cylinder coming through the engine block.

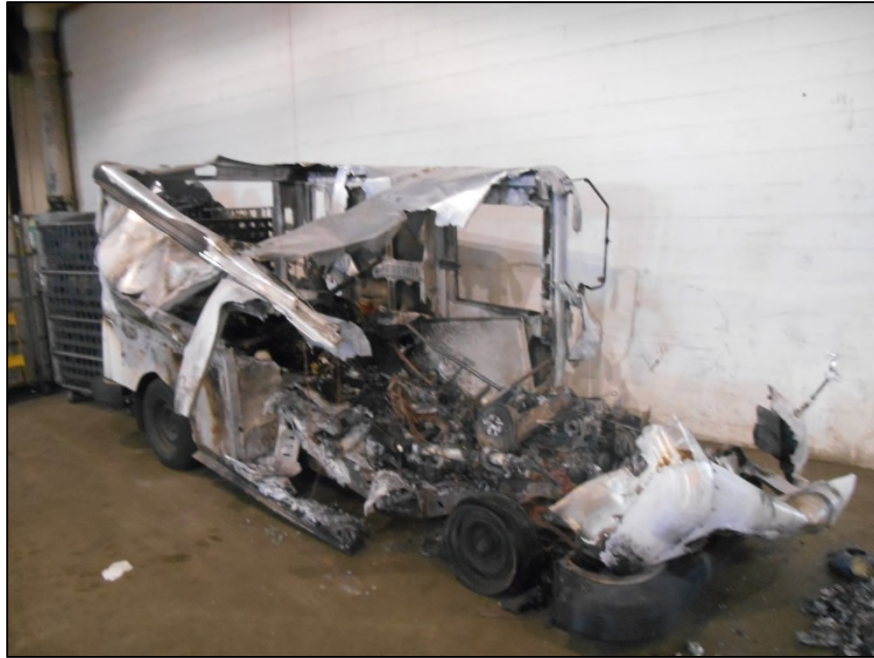
Photograph 5

The remaining portion of the LLV.

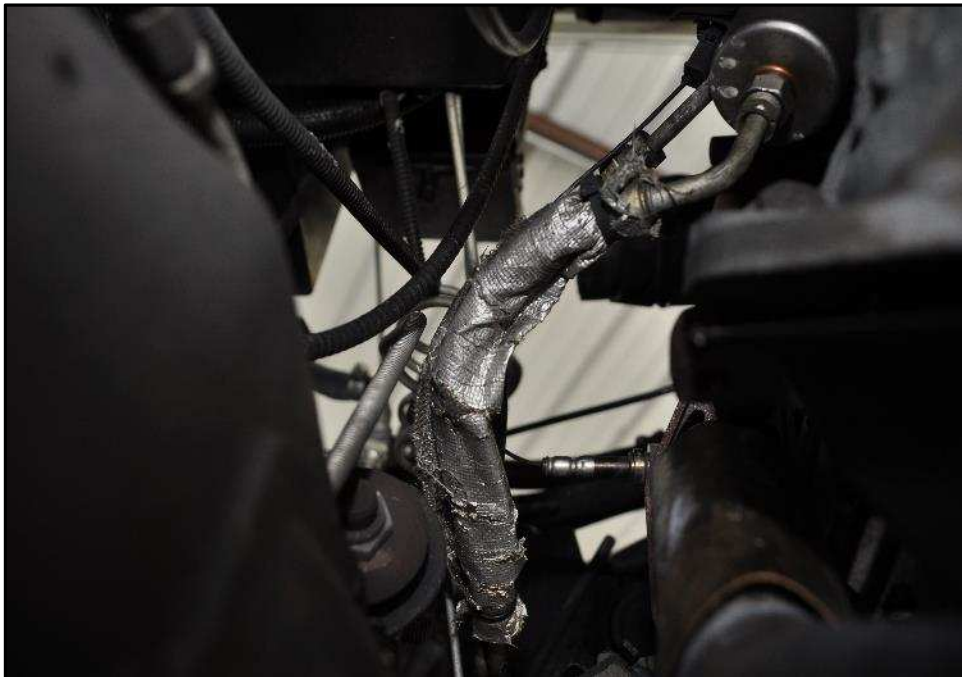
Photograph 4

The fuel tubing and the in-line fuel filter as viewed from the undercarriage.

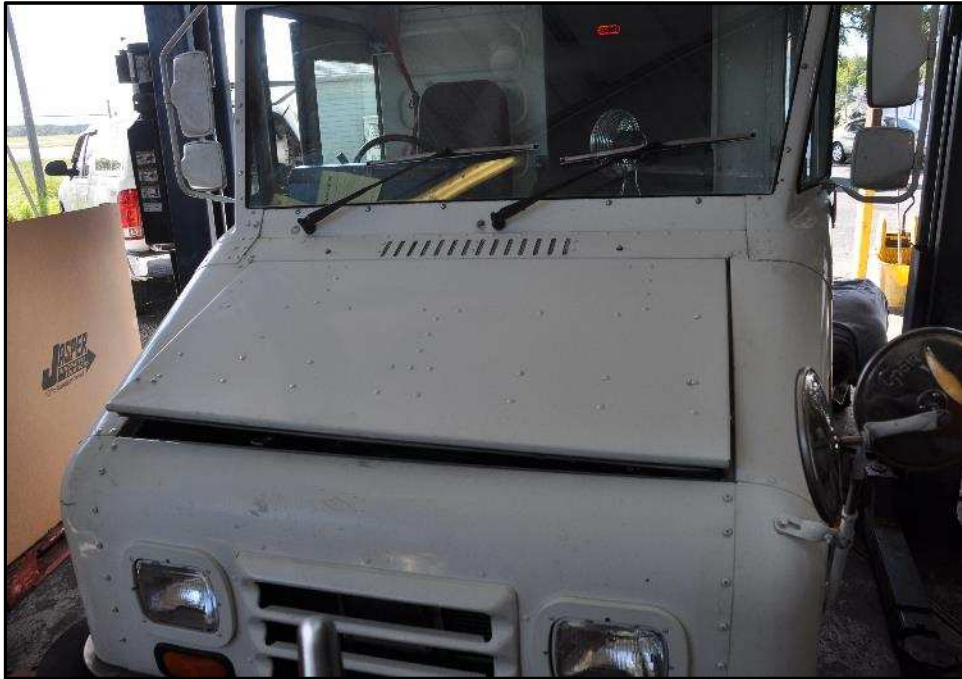
Photograph 5

Front view of the exterior of the vehicle.

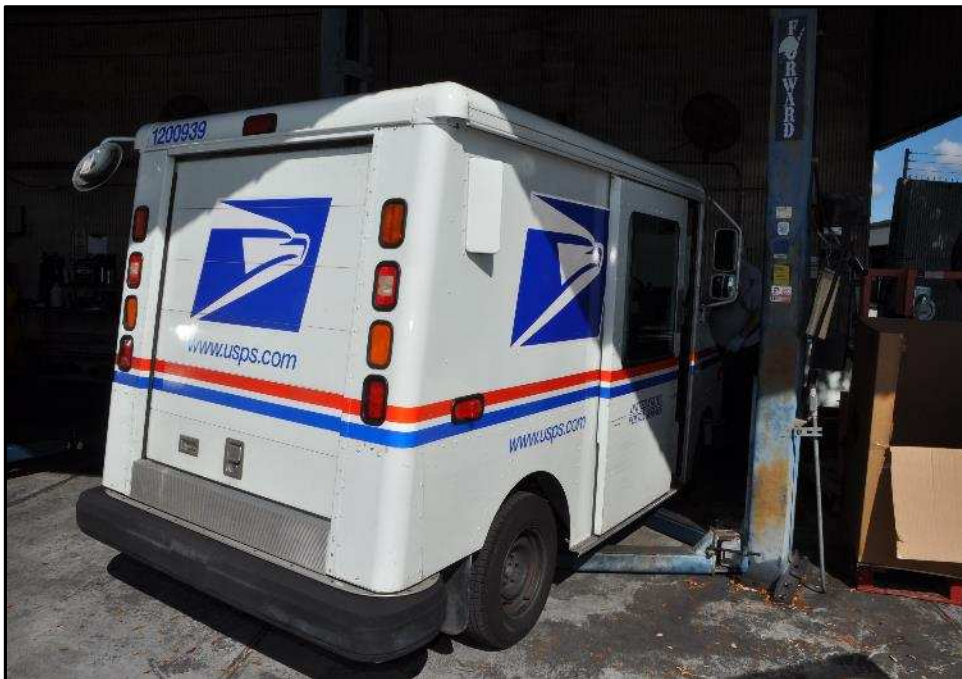
Photograph 6

View of the driver's side and rear load door.

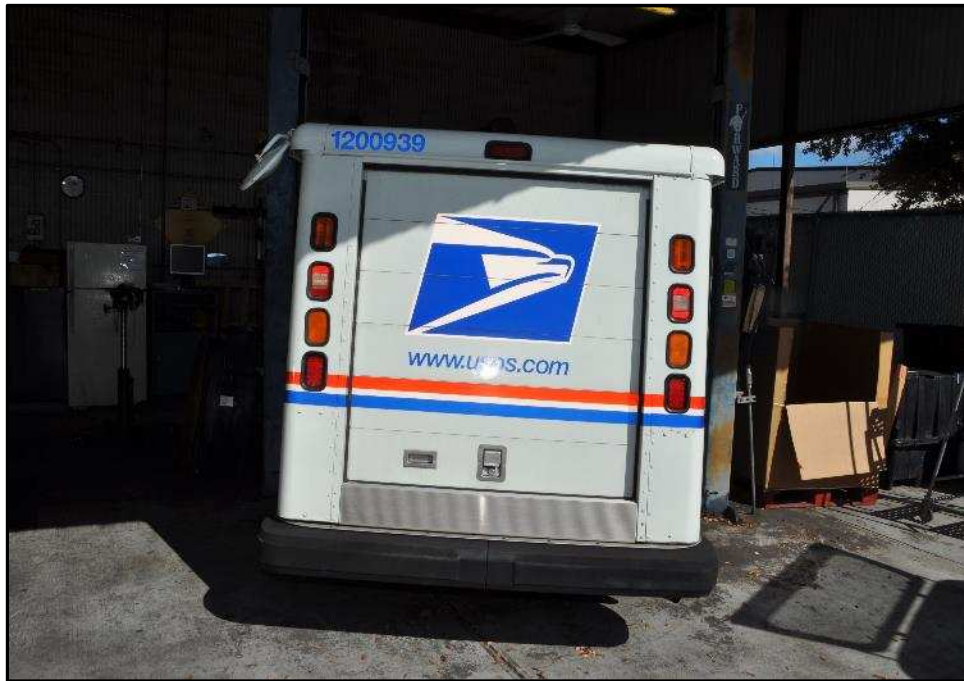
Photograph 7

View of the rear-loading door.

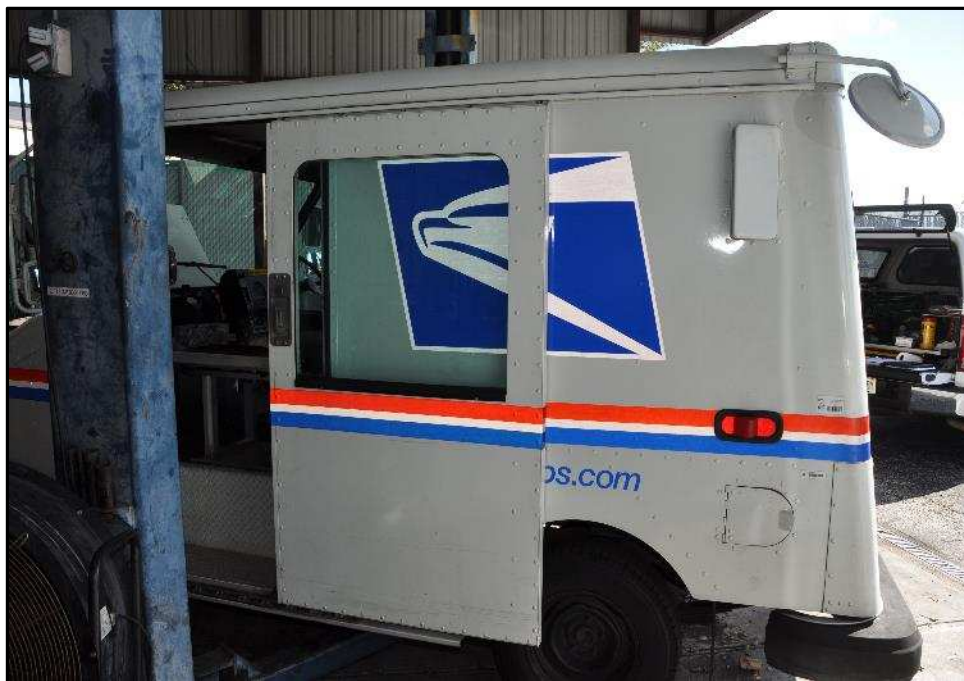
Photograph 8

View of the passenger side of the vehicle.

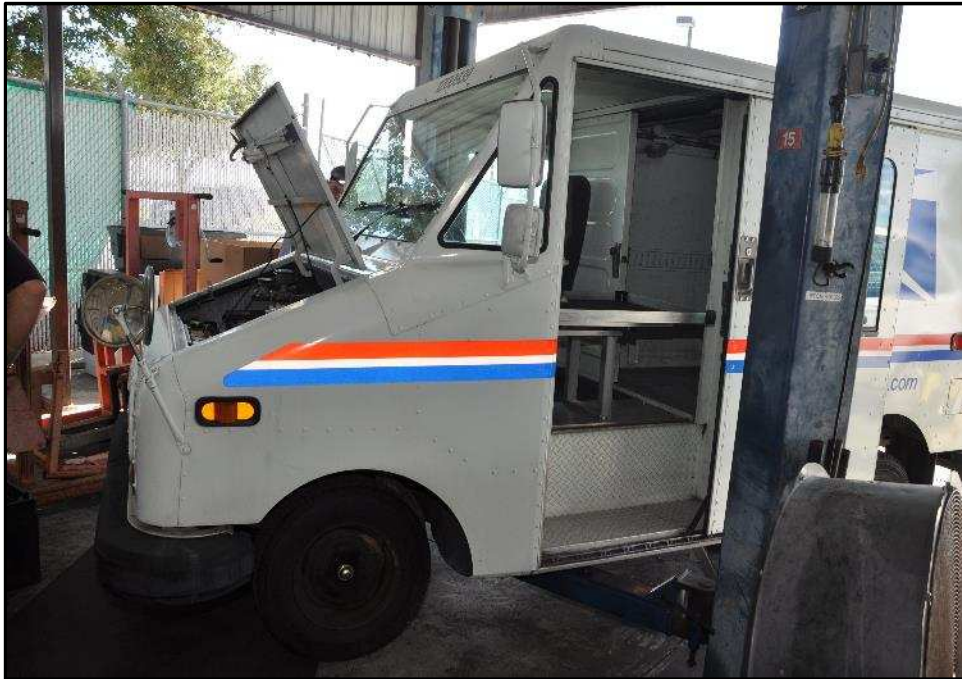
Photograph 9

View of the passenger side and the loading door.

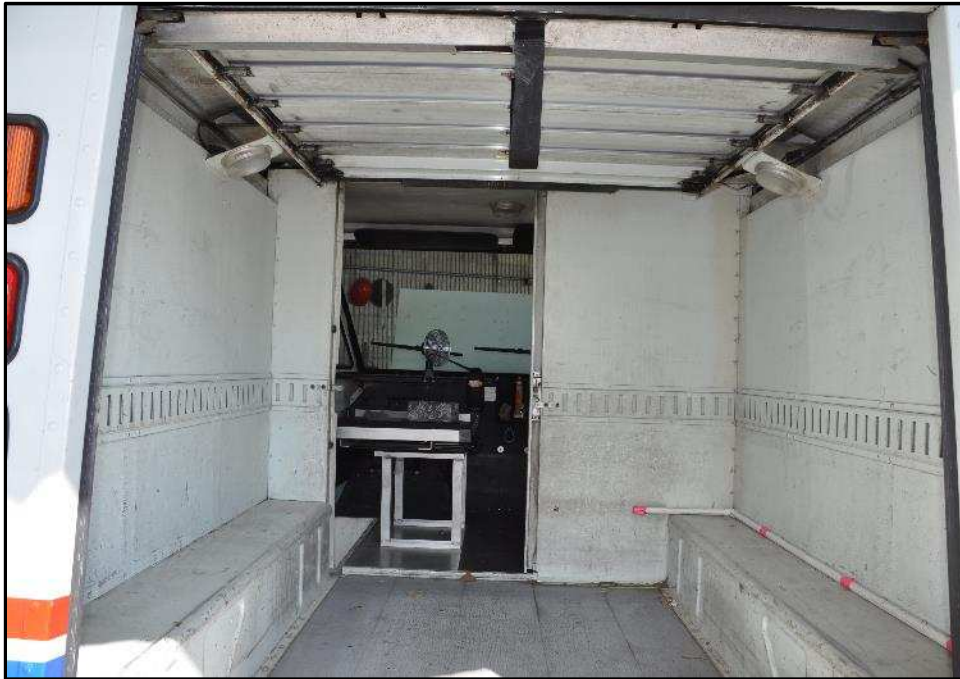
Photograph 13

View of the interior of the cargo compartment from the rear of the vehicle.

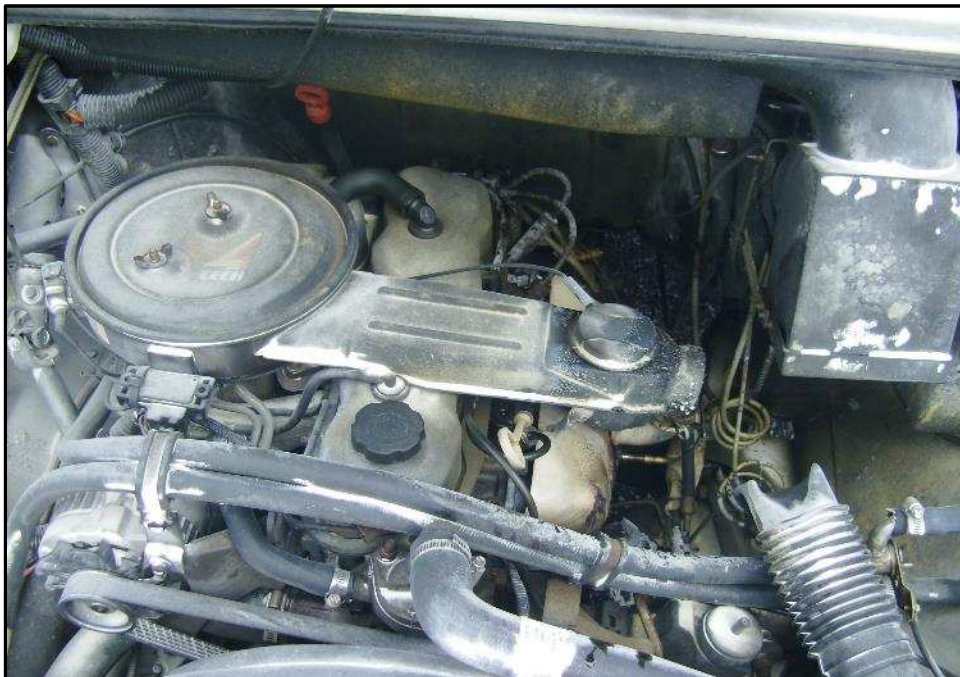
Photograph 14

The examination next progressed to the engine compartment where the most severe heat and fire damage was observed (**Photograph 14**). Based upon the burn pattern analysis of the vehicle and the engine compartment, it is our opinion the fire originated within the engine compartment and the point of fire origin was identified as being on the right side of the engine as viewed from the front of the vehicle. Prior to our examination, staff at the VMF cleaned the engine to remove dry chemical extinguishing agent and during the cleaning removed the residue of oil observed immediately following the fire. Additionally, the heat shield and other operational components had been removed. Examination of the heat shield revealed severe heat and fire damage and residue of burned engine oil on the exterior and interior of the shield (**Photographs 15 and 16**). Examination of additional components removed revealed oil residue within the air intake ductwork (**Photograph 17**). The area and point of fire origin was reconstructed by re-installing the heat shield. Once re-installed in position, the point of greatest heat and fire damage was identified directly beneath the engine oil dipstick.

View of the engine compartment as documented by USPS staff following the fire.

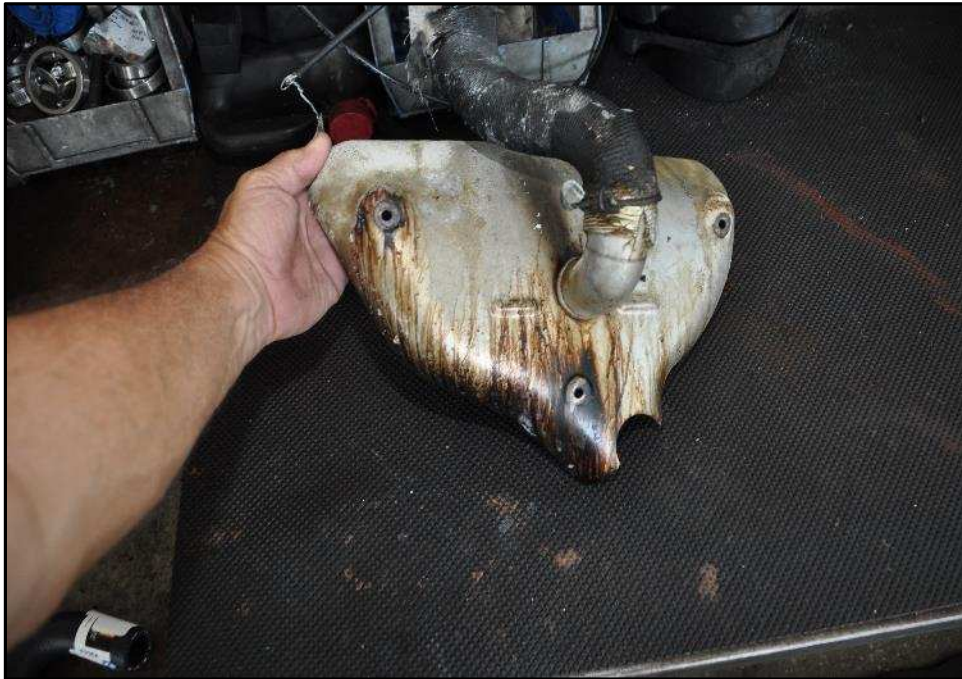
Photograph 15

View of the exterior of the oil stained and heat damaged heat shield from the engine.

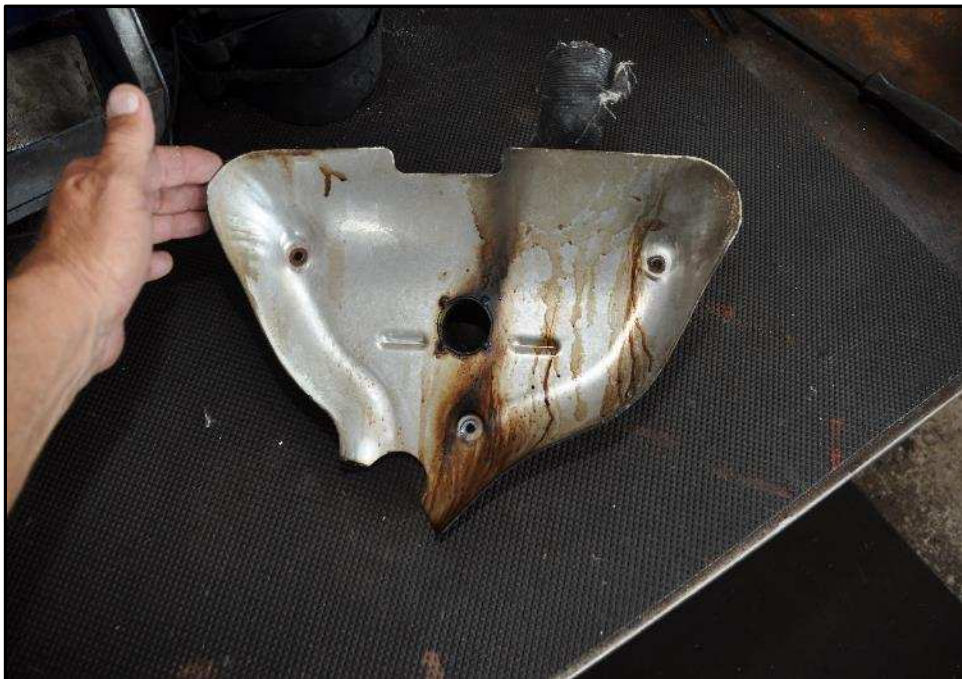
Photograph 16

View of the interior of the oil stained and heat damaged heat shield.

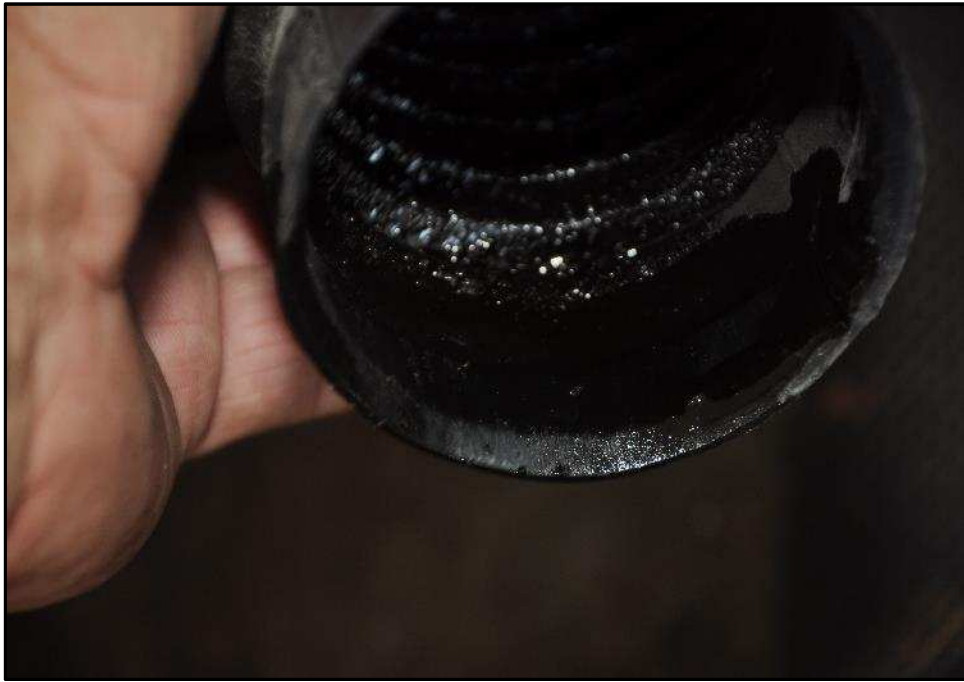
Photograph 17

View of the air intake hose revealing a build-up of oil deposits.

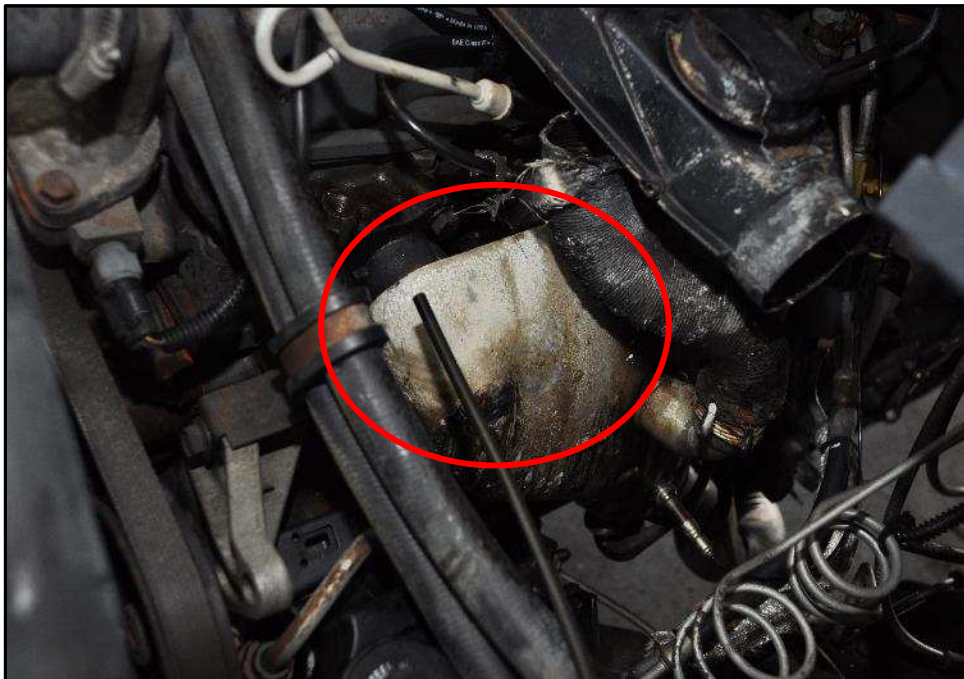
Photograph 18

View of the heat shield following re-installing it to the position at the time of the fire. Note the high temperature area that has been circled and proximity to the oil dipstick.

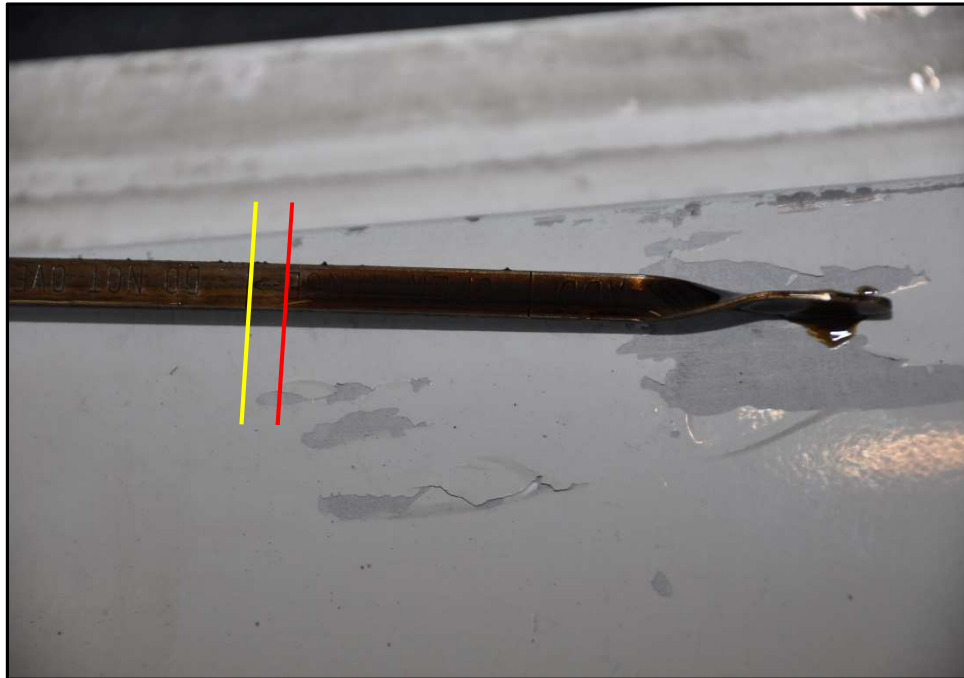
Photograph 19

View of the engine oil level dipstick revealing level of oil during the examination.

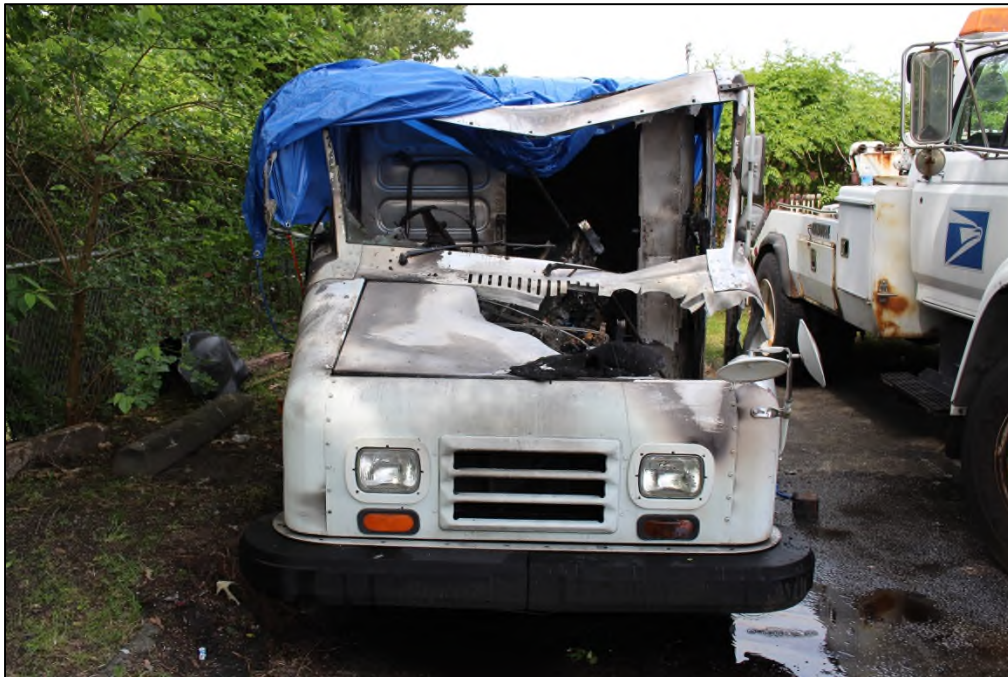
Photograph 1
Front of vehicle.

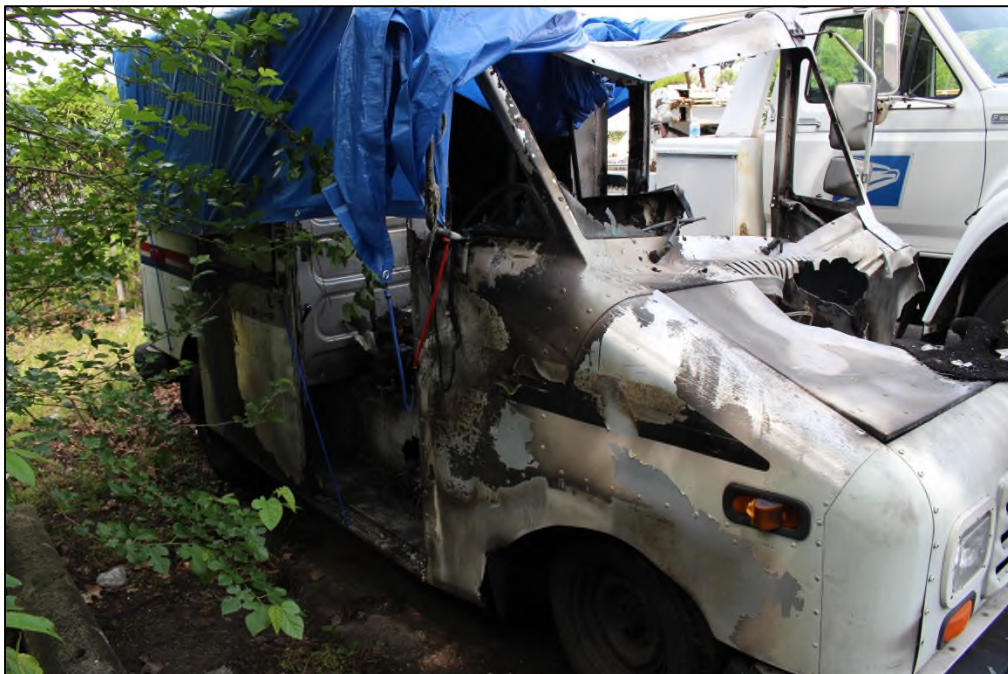
Photograph 2
Right side of the vehicle.

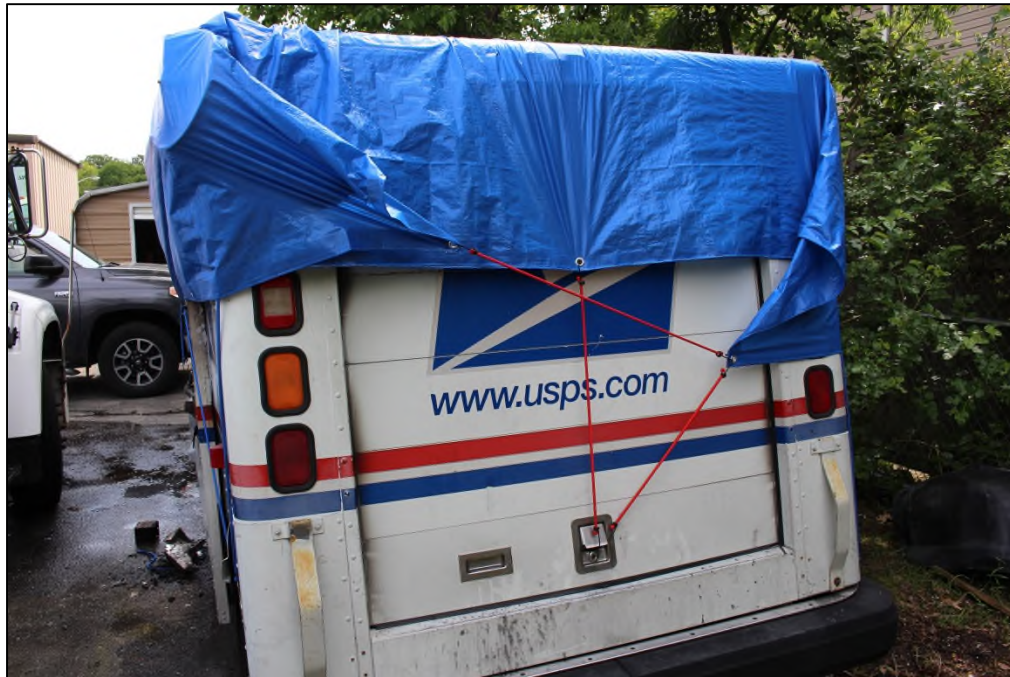
Photograph 3
Back of vehicle.

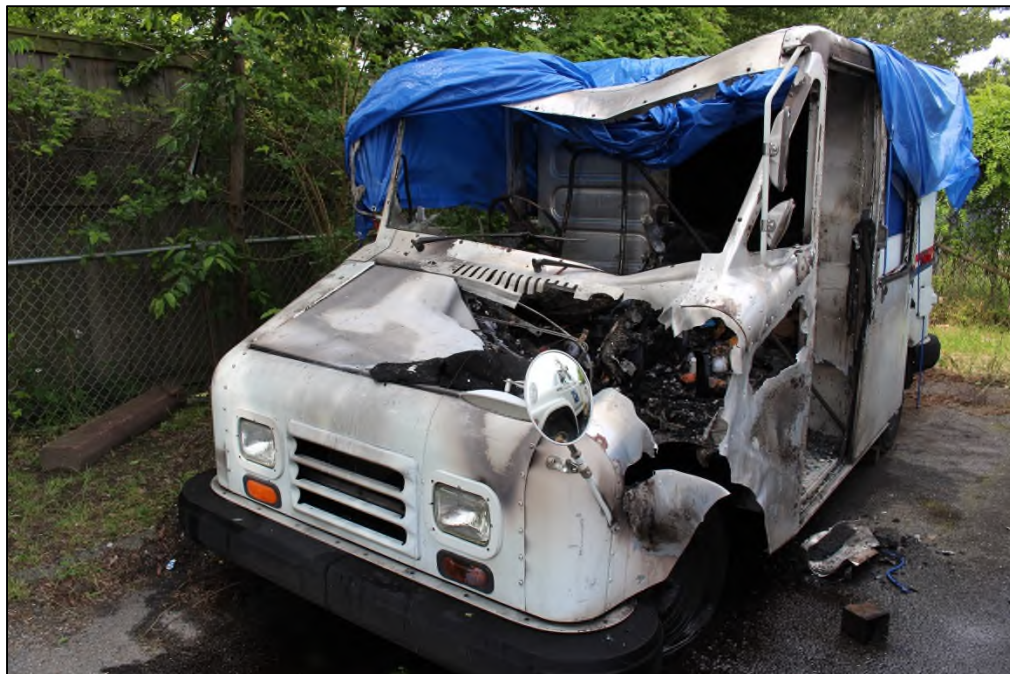
Photograph 4
Left side of the vehicle.

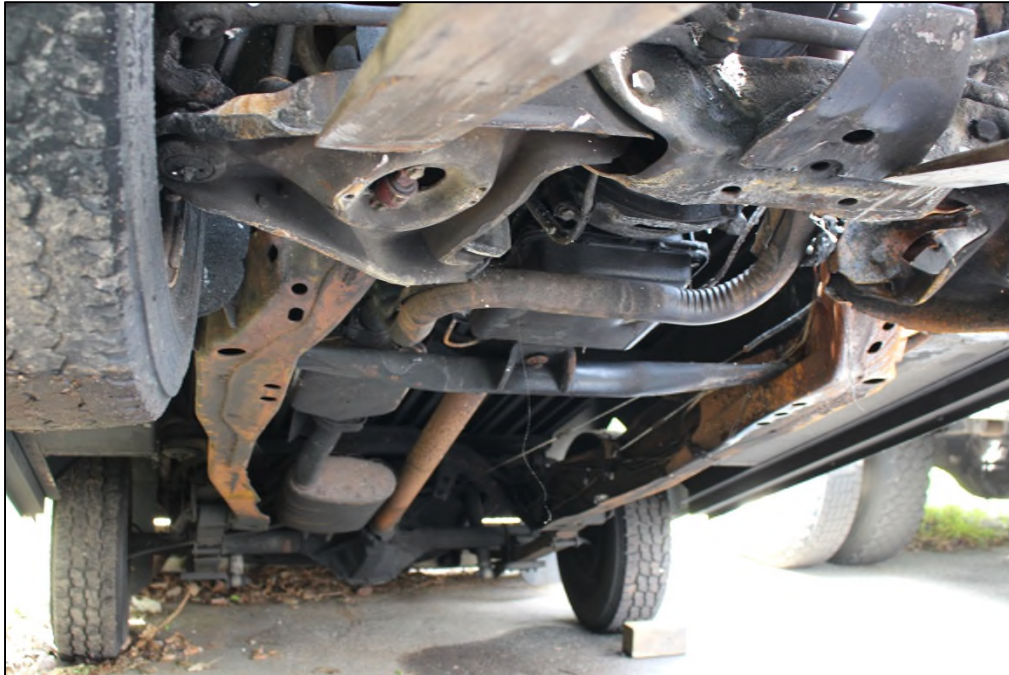
Photograph 5
View of the undercarriage.

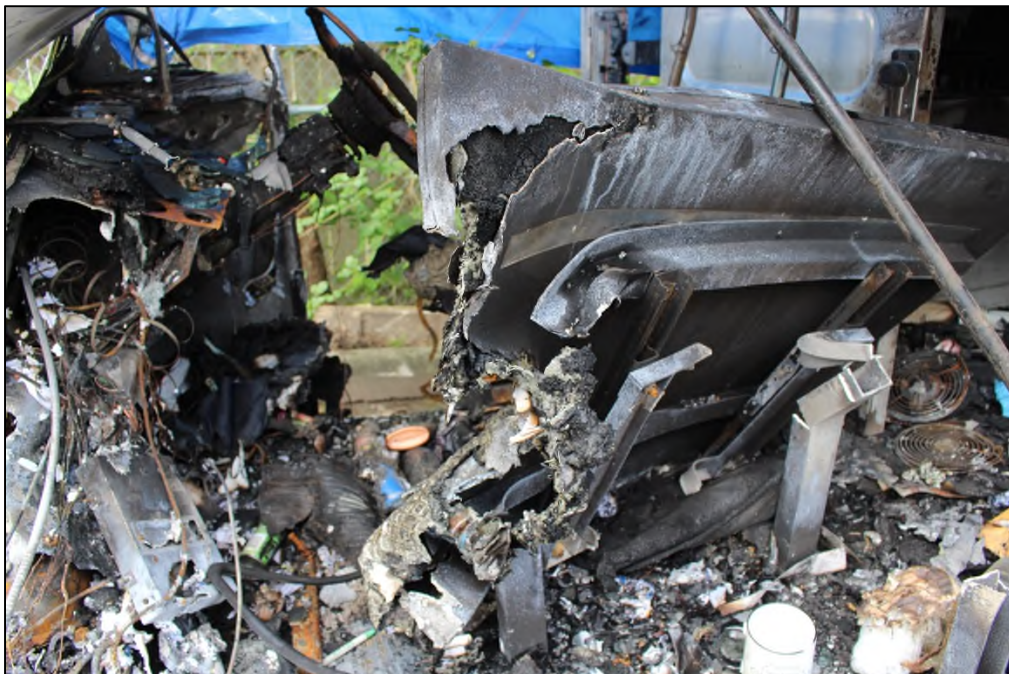
Photograph 6
Interior view of vehicle.

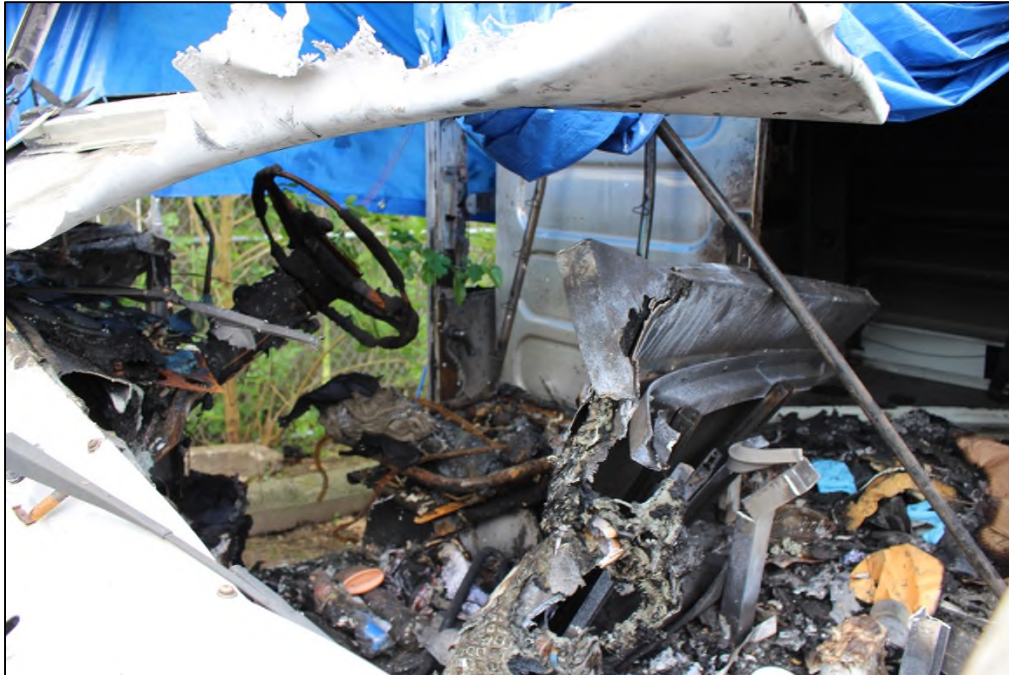
Photograph 7
Interior view of vehicle.

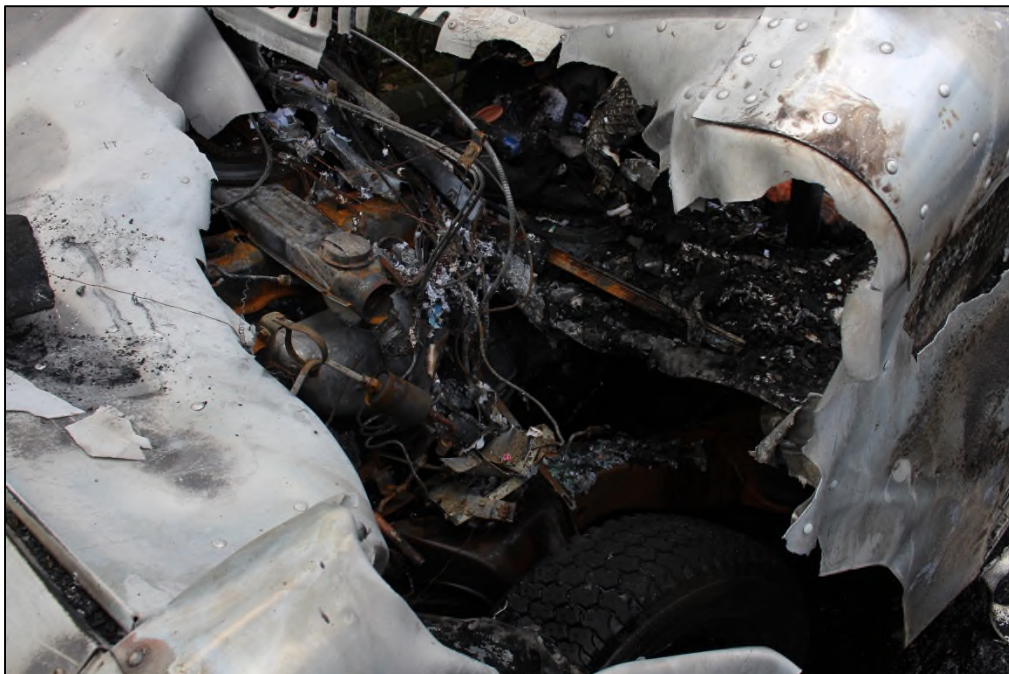
The left fender, engine hood, and the roof above the operator's area displayed significant fire damage. The cargo area only displayed minor fire damage. Interior Inspection:

Photograph 8
Fire damage to the left side of engine hood.

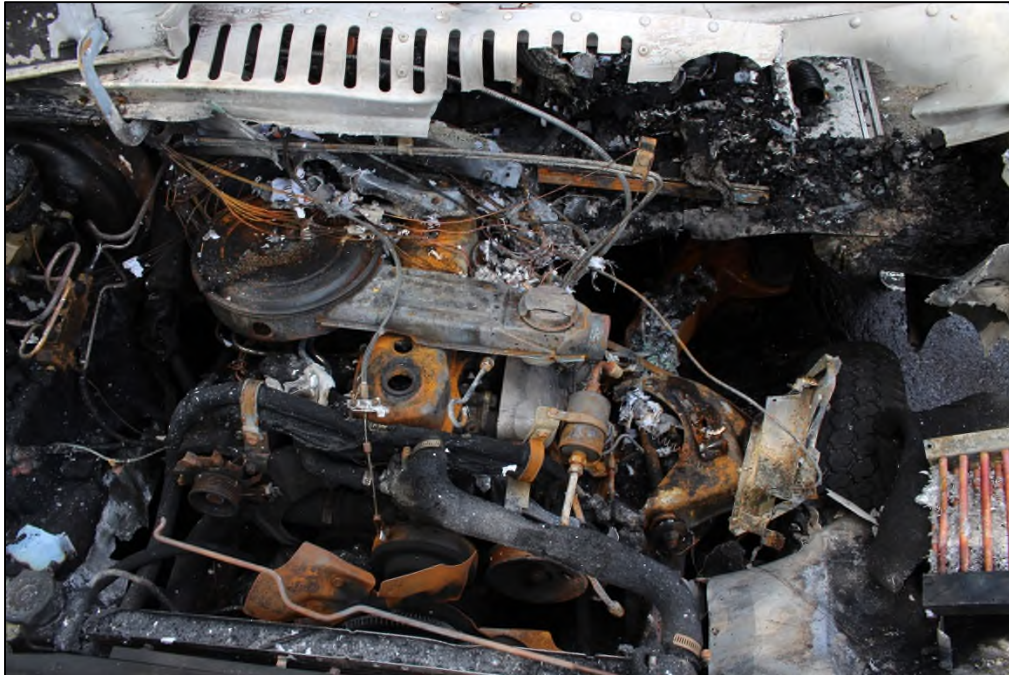
Photograph 9
View of engine compartment.
